# MCR FUSE 24/25 Tail Sizing

## Bending/Torsion Tests

This document is to serve as a summary of the bending and torsion tests done on the prototypes of Design 1: Balsa Strut Design, and Design 2: Carbon Fiber longerons, to determine which design is preferred for the 2024/25 MCR plane.

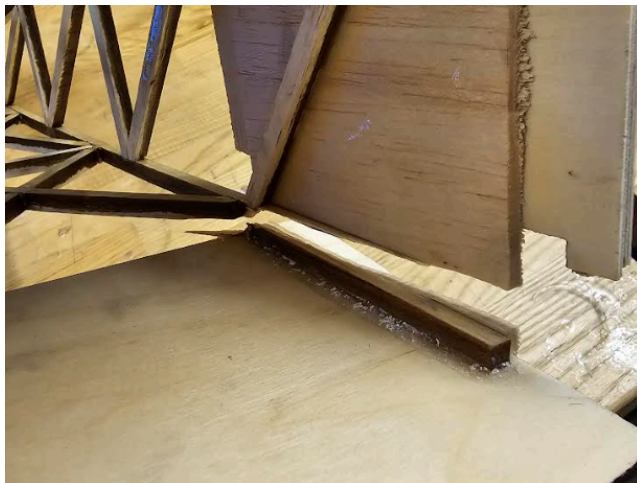
Held up 10.6 lbs before breaking (measured with a notsoaccurate scale)

Broke at base where the top left longeron broke along its grain. Surprisingly not where i reglued the longerons.

Upward force: 10.6 lbs

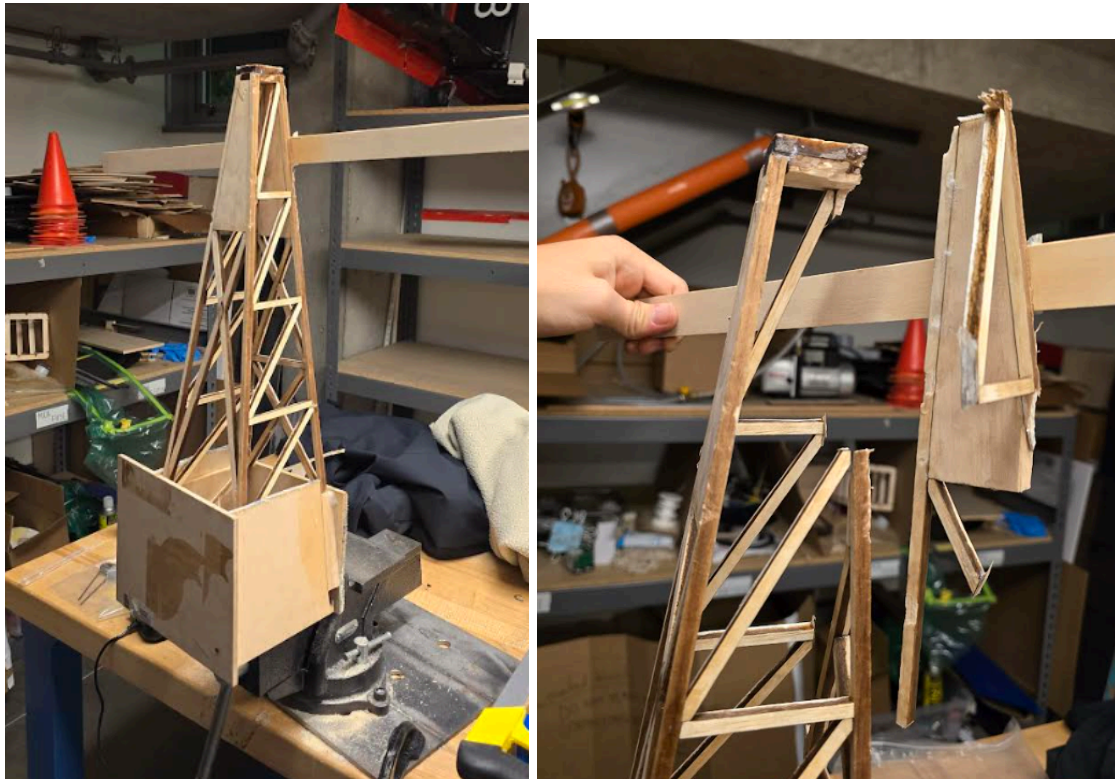
# Balsa strut torsion test #1

On the left is the setup, on the right is the failure points, which were located on the connection points between the balsa stringers at the end.

Notably, not a lot of force was used when bending so that might be a downside.

Torsion wise, it felt a lot sturdier compared to the balsa design where the balsa would split down the grain during torsion, this design handles much better at torsion because of the kevlar strings (without the kevlar strings, it bends just by someone looking at it.)

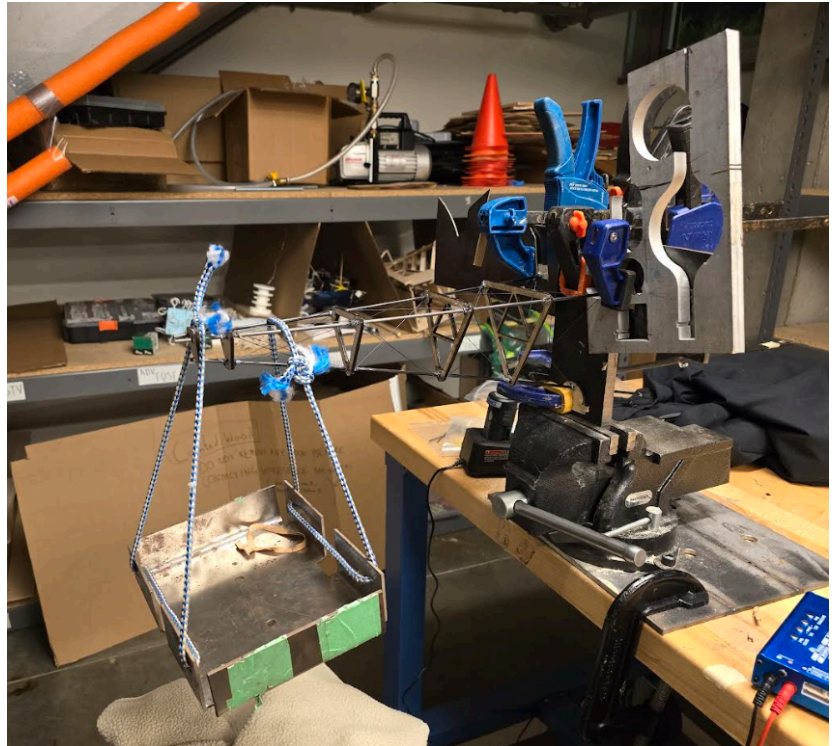
# Carbon fiber longerons bending test #1: bending test

Originally i had designed bulkheads to support this but the bulkheads were too weak and so i clamped it onto a metal vice to simulate a "fixed" point.

Due to the complexity, material, and price, only 1 of these tests could be done per tail but each side is designed nearly the same so it should withstand similar amounts of force.

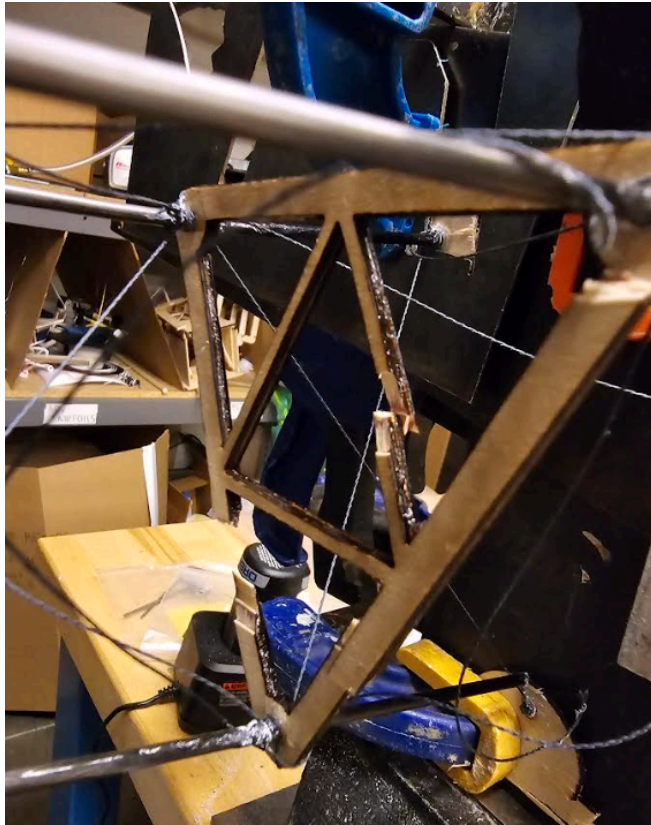
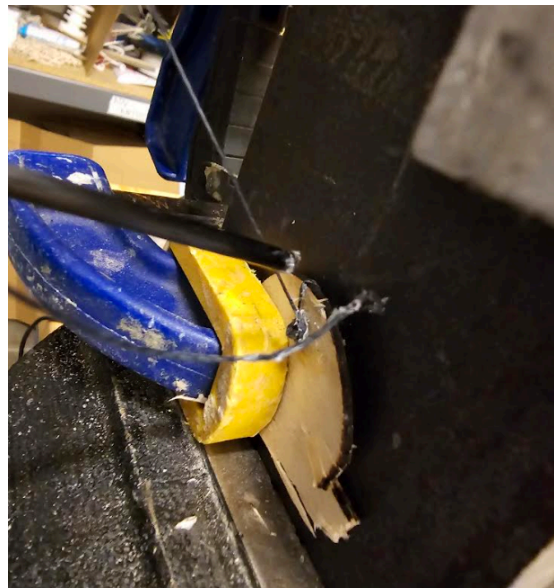
Serious bending at around 15 lbs of metal

Limit: 19.0 lbs of metal

Broke at 19 lbs of metal.

A little blurry but the 2 main points of failure was the first bulkhead and the 2 left carbon fibre longerons at the base. No kevlar string snapped during this whole process.

Downward force: 19.0 lbs

Where the balsa barely showed deformations before having a quick snap break, this design started seriously bending at around 15 lbs and snapped at 19 lbs, where i think there is a good benefit to have an indicator as to when a part is going to fail rather than a sudden collapse (looking at you OceanGate (o\_0) ).
